VALIDATION OF A THERMAL HISTORY PAINT ON A TURBINE BLADE IN A HOT GAS RIG FACILITY

1. ABSTRACT

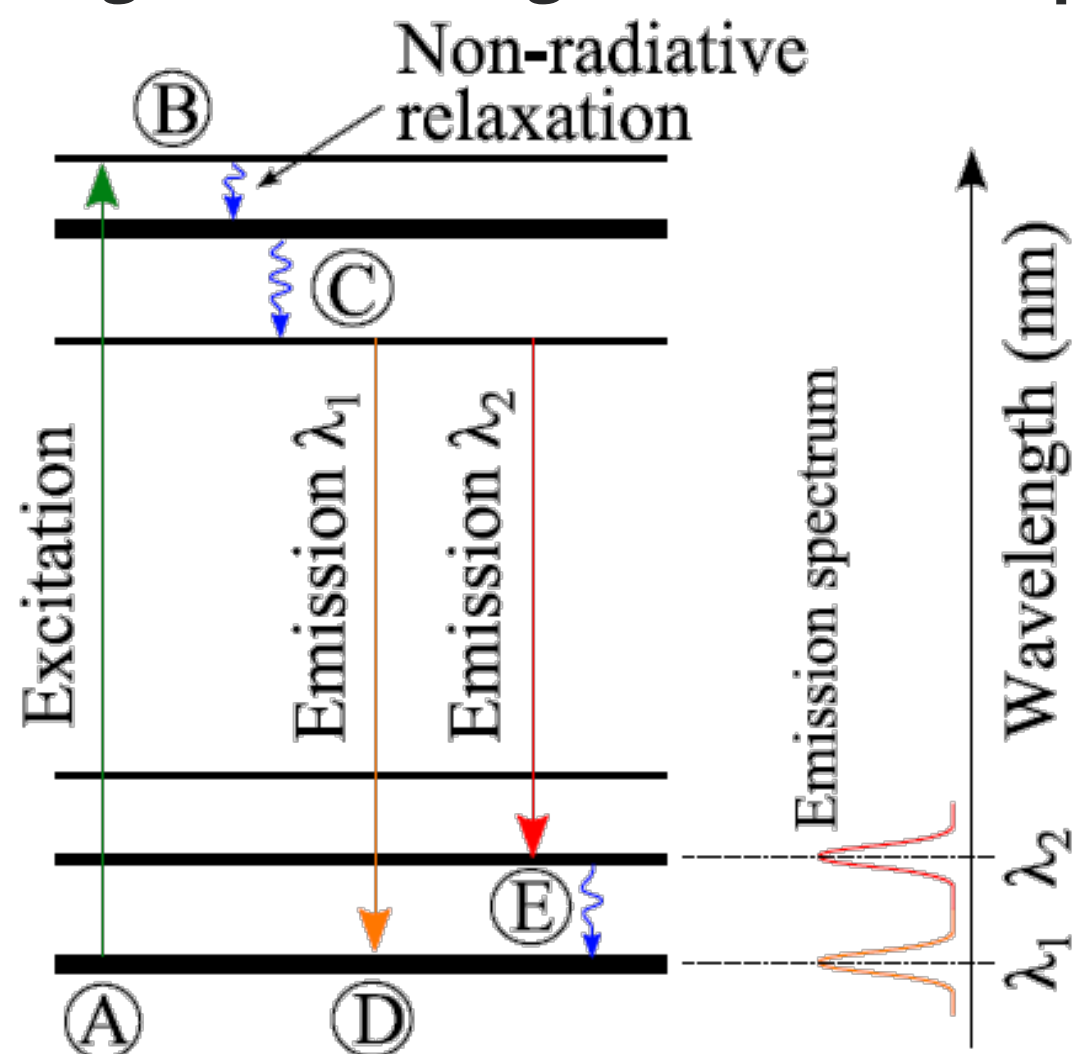
Rare earth ions act as atomic level sensors. When irradiated with light, electrons promote to higher energy states. The relaxation happens via two competitive processes, radiative and non-radiative. Permanent changes in their internal structure due to heat exposure causes crystallisation and fixes temperature information. Lifetime Decay can be measured providing sensitive thermal profiles.

Energy level diagram showing luminescence process:

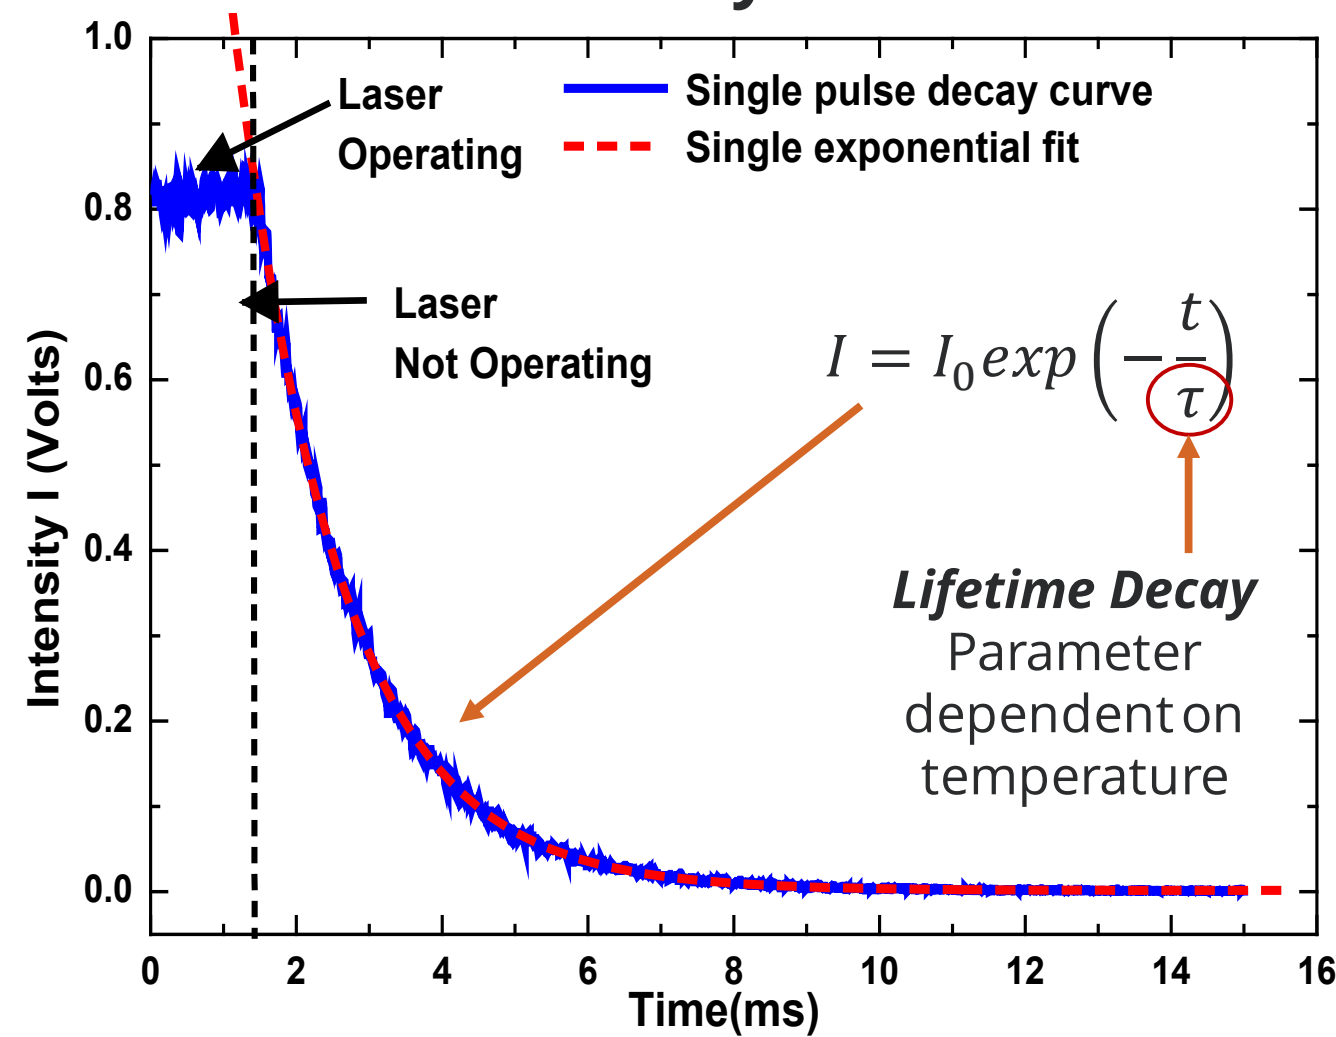
Phosphorescence lifetime decay:

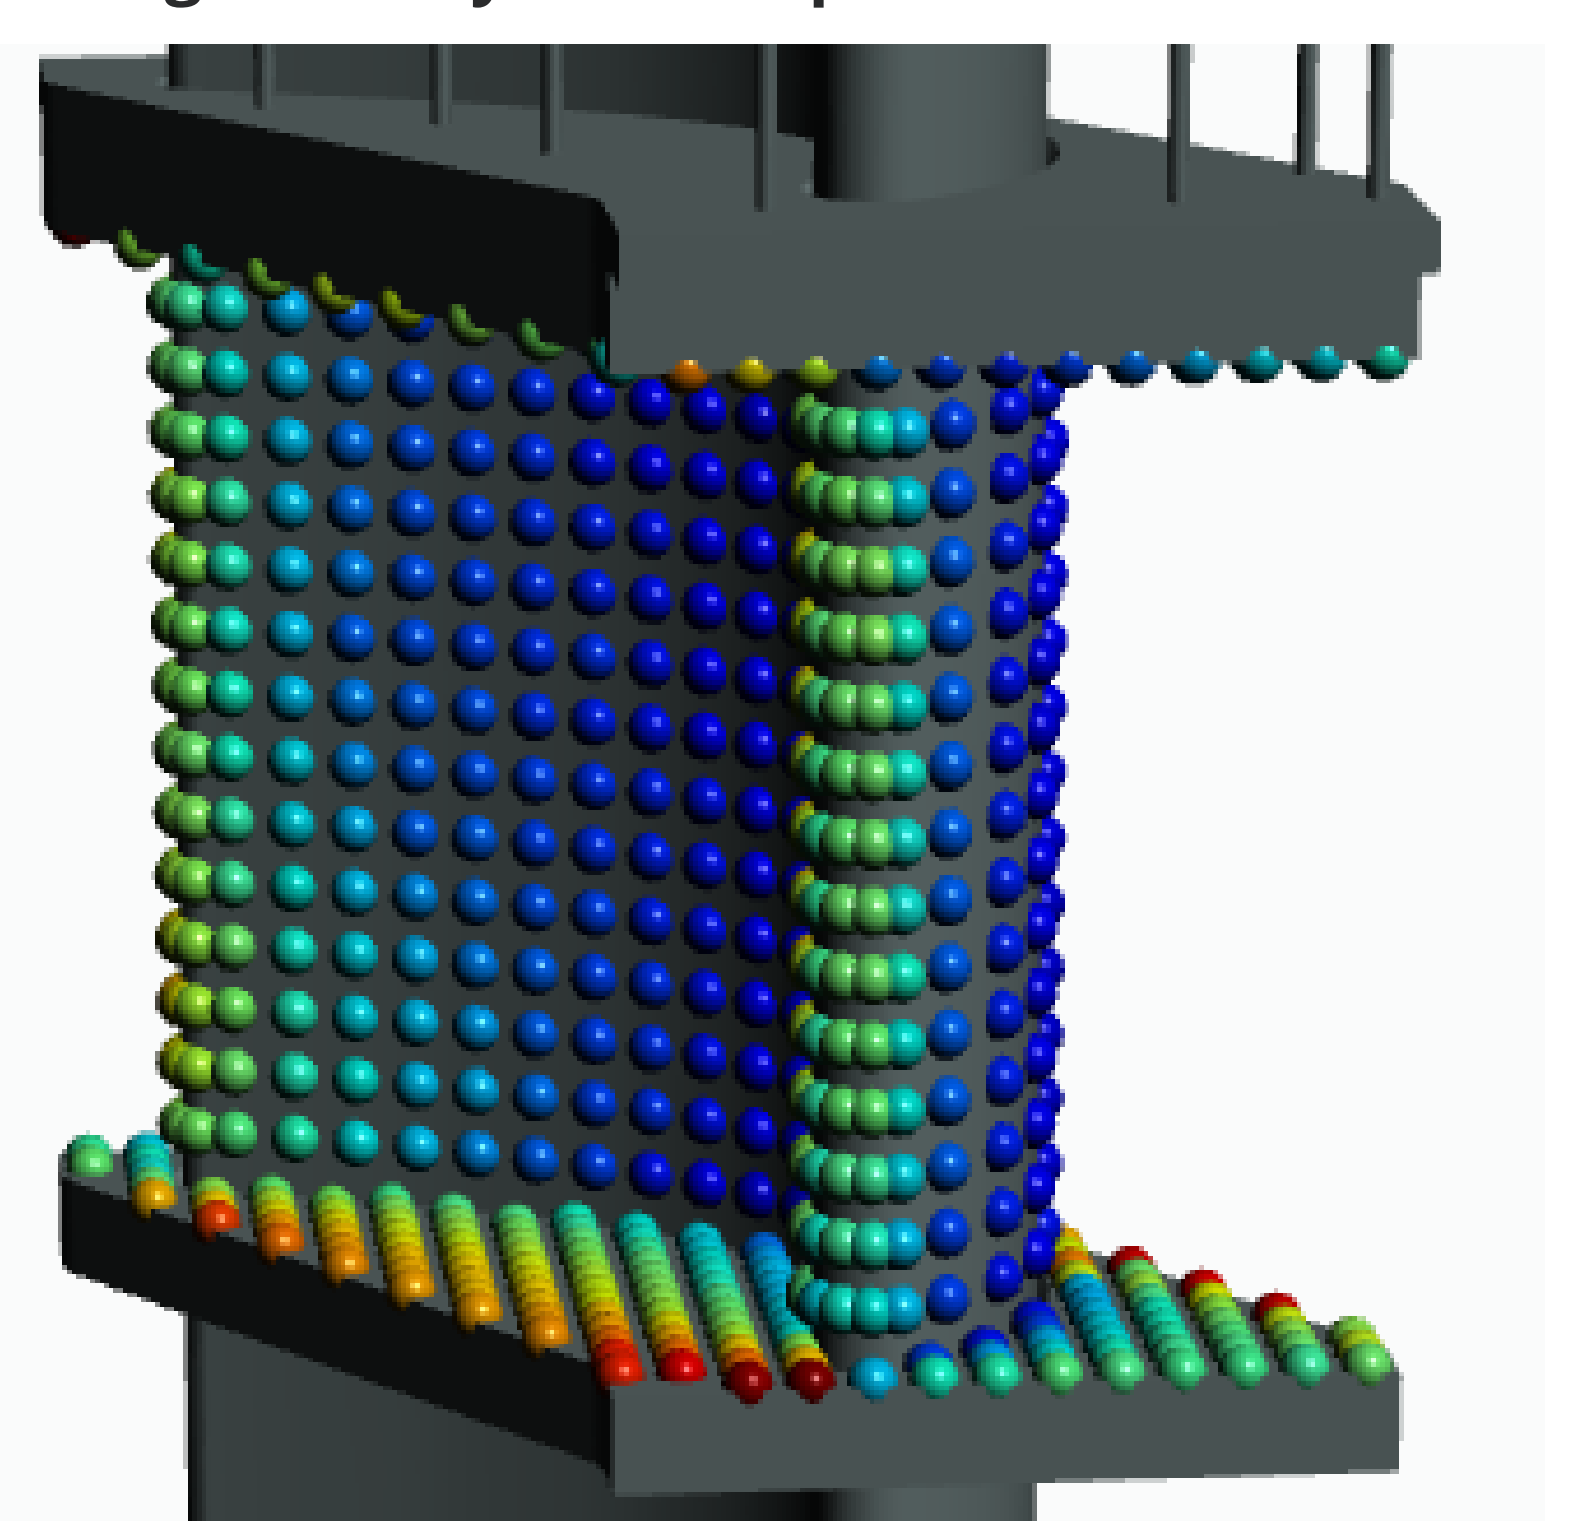
Validated high density thermal profile:

Over 1,000 temperature measurements were acquired on Thermal History Paints. Results show very good agreement with thermocouple and FEM analysis, from previous publications. An accurate temperature profile was recorded. This new temperature measurement technique was validated.
