ICONE28-POWER2020-XXXXX

FEASIBILITY STUDY FOR AN ULTRASONIC SENSOR FOR MONITORING WHEEL FLANGE CONTACT

First Author, Second Author
University of Sheffield, Sheffield, UK

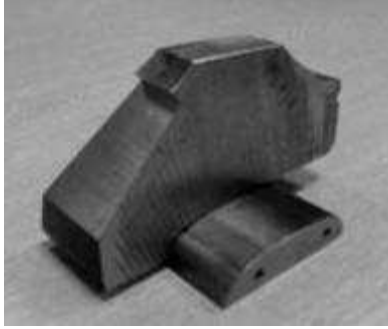
The wheel and rail specimens used in the experimental work were cut from sections of UIC 60 900A rail steel and R8T wheel steel (shown in Figure 2). The specimens were from used sections of rail, and exhibited some minor wear and surface polishing. The upper wheel specimen has had a flat surface machined at 47° degrees to the wheel axis. The transducer was coupled to this flat surface with a gel based couplant. The transducer was moved around on the face until a maximum reflection was achieved. The orientation of the plane (47°) was chosen to maximize the line of site between the transducer and the flange contact zone.

Figure 2. Photograph of the wheel and rail test specimen in contact.

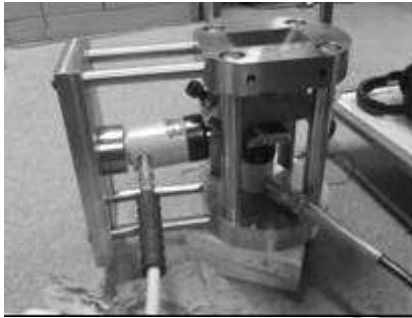
A frame and two hydraulic cylinders shown in Figure 3 were used to normally and tangentially load the specimens together.

Figure 3. Photograph of the loading frame, showing the two hydraulic cylinders for applying normal and lateral loads.

Normal forces, varying from 0 to 80 kN in the vertical direction, were applied using an Enerpac hydraulic cylinder which was located below the wheel/rail specimens. Another hydraulic cylinder was used to generate lateral forces from 0 to 9 kN in the horizontal direction. As the wheel/rail components had no constraint in the horizontal direction, lateral force would cause relative sliding between wheel and rail. A large enough normal load must be applied to prevent this sliding. Applying a lateral load of more than 9 kN to a contact under a load of 80 kN caused gross slip to occur. The coefficient of friction was somewhere in the region of 0.1 to 0.12.

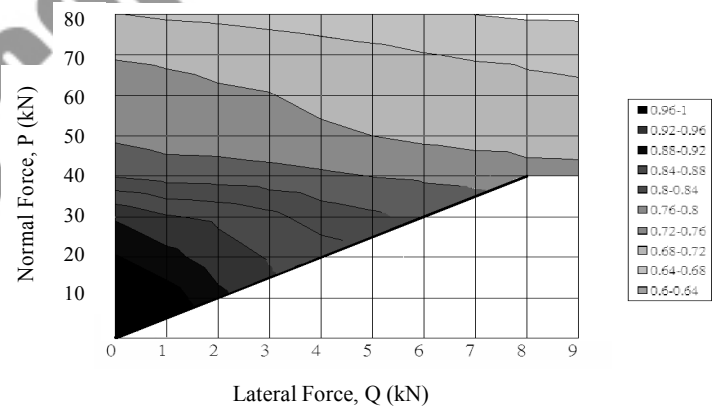
In further tests, series lateral as well as normal loads were applied to the specimens. Figure 8 shows a map of the measured reflection coefficient as it varies with normal and lateral loads.

Figure 8. Map of reflection coefficient variation with normal and lateral load.

Nevertheless they show that the flange contact region is increasing with lateral load. It would be expected that this would cause a reduction in the reflection coefficient, as observed in figures 7 and 8.

The results have shown that a single ultrasonic transducer can be placed on the wheel and is sensitive to both increasing normal load and lateral load. The map shown as figure 8 demonstrates that there is enough sensitivity to deduce whether flange contact is occurring and the level of the lateral load. It is theoretically possible for the rail to make contact at any wheel location from the flange throat to the flange face. In this work only locations at the throat have been studied and at this stage the range of possible positions that can be measured has not been identified. A more detailed study of the transducer location could both improve the sensitivity of the measurements and define what flange contact positions are best observed. Further work will be carried out to model the ultrasonic ray passage through the combined wheel-rail assembly in a wider range of configurations to ensure the best location is chosen.
