## FEASIBILITY STUDY FOR AN ULTRASONIC SENSOR FOR MONITORING WHEEL FLANGE CONTACT

**First Author, Second Author**  
University of Sheffield, Sheffield, UK

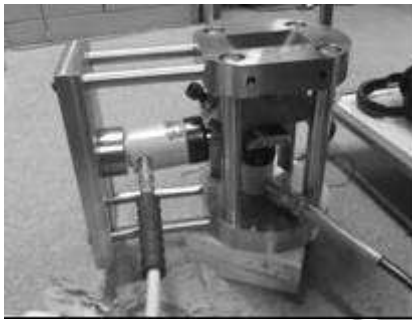
A frame and two hydraulic cylinders shown in Figure 3 were used to normally and tangentially load the specimens together.

Figure 3. Photograph of the loading frame, showing the two hydraulic cylinders for applying normal and lateral loads.

Normal forces, varying from 0 to 80 kN in the vertical direction, were applied using an Enerpac hydraulic cylinder which was located below the wheel/rail specimens. Another hydraulic cylinder was used to generate lateral forces from 0 to 9 kN in the horizontal direction. As the wheel/rail components had no constraint in the horizontal direction, lateral force would cause relative sliding between wheel and rail. A large enough normal load must be applied to prevent this sliding. Applying a lateral load of more than 9 kN to a contact under a load of 80 kN caused gross slip to occur. The coefficient of friction was somewhere in the region of 0.1 to 0.12.
